# DAMP & TIMBER SURVEY

**PROPERTY:****Bishop's Stortford CM23, UK**

REF NO: 15112200

**SURVEY PREPARED BY:****Ed Harrison (FODCS Certificated Damp Surveyor)**

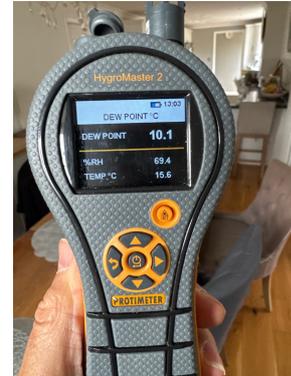
Temperature: 15.7°C  
Relative Humidity: 69.4%  
Vapour Pressure: 1.24 kPa  
Dew Point: 10.1°C  
Absolute Humidity: 9.30 g/m<sup>3</sup>  
Water Activity: 0.696 (aw)

**The water activity within the property registered; 0.696 aw to indicate that in real time the home is approaching thresholds for elevated moisture and condensation risks.**

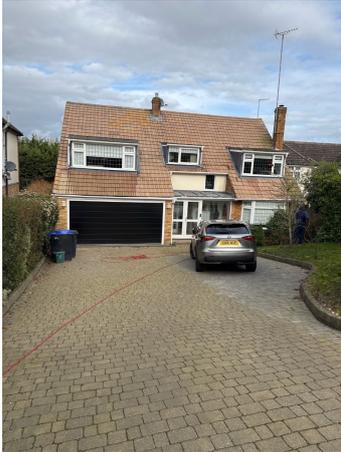
### FRONT OF EXTERNAL PROPERTY

Brickwork to the principal elevation appears generally sound. Localised mortar deterioration and minor open joints were observed at low level and at isolated bed joints. While these defects may permit minor water penetration during periods of driving rain, no evidence was identified to suggest significant or sustained moisture ingress affecting internal habitable areas.

The pitched tiled roof was inspected from ground level only. No slipped tiles were visible from the front elevation at the time of inspection. The porch area, however, exhibits internal staining consistent with localised water ingress, suggesting a defect to the porch roof covering, flashing, or junction detail. This should be investigated further at roof level.

- No evidence of structural rising damp identified.
- No obvious façade defects consistent with widespread penetrating damp.
- Localised mortar deterioration noted — routine maintenance item.
- Porch roof area likely source of ceiling staining — separate localised defect.

The ceiling staining observed within the porch area is consistent with active water ingress.

A competent roofing contractor should undertake a close-up manual inspection of the porch roof covering, flashings, abutments, and junction details. Any defective tiles, coverings, or flashings should be repaired or replaced as necessary to prevent further moisture penetration.

Following repair and confirmation of dryness, internal finishes may be redecorated.

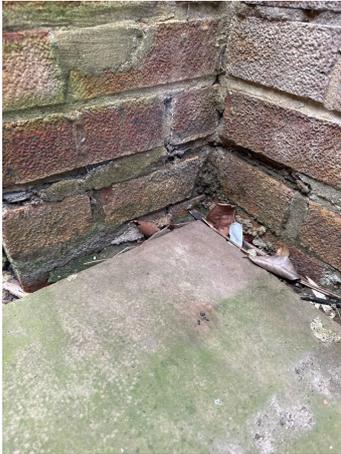
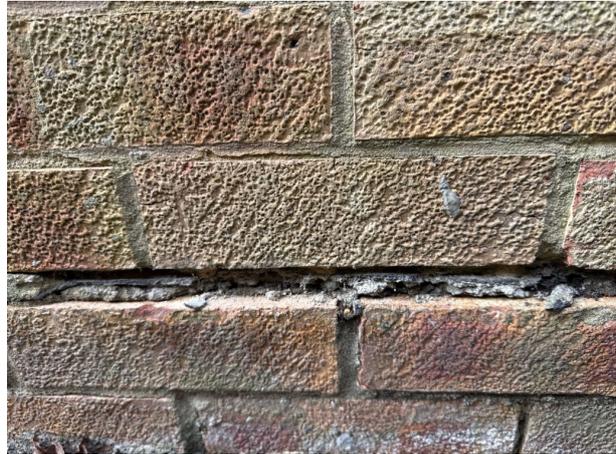
## SIDE ELEVATION

Localised mortar erosion and open bed joints observed at low level.

These defects are consistent with natural weathering and are considered maintenance-related.

The moisture pattern is consistent with transient external wetting and restricted evaporation, not rising damp.

Localised open bed joints and mortar erosion should be repointed using an appropriate mortar mix compatible with the existing masonry. This is considered routine external maintenance to preserve weather resistance and prevent progressive deterioration.

It is recommended that the substantial bush/shrubbery positioned opposite the extension corner be reduced or pruned back to:

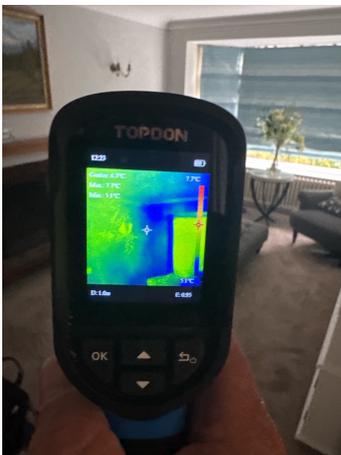
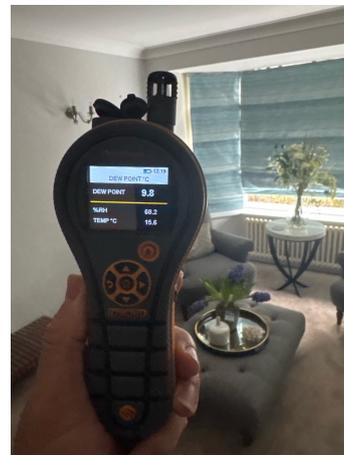
## LIVING ROOM

Vapour Pressure: 1.18 kPa | Relative Humidity: 68.2% | Temperature: 15.6°C | Dew Point: 9.8°C | Absolute Humidity: 9.08 g/m<sup>3</sup> | Water Activity: 0.683 (aw)

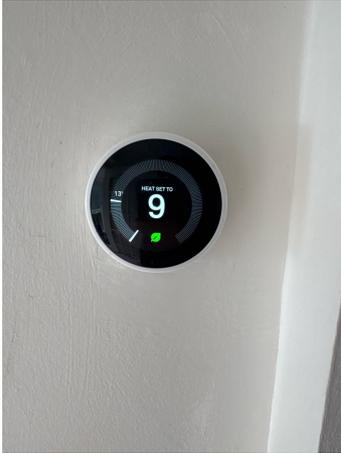
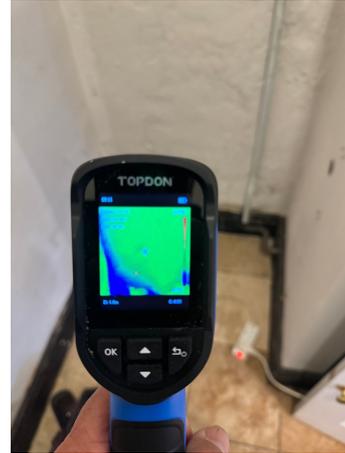
## HALLWAY + PORCH

Staining was observed to the ceiling within the porch area. The appearance and pattern of staining are consistent with water ingress from above. This is considered separate from the broader internal environmental conditions identified elsewhere in the dwelling and is indicative of a localised defect requiring further investigation and repair at roof or flashing level.

Vapour Pressure: 1.20 kPa | Relative Humidity: 67.4% | Temperature: 15.8°C | Dew Point: 9.8°C | Absolute Humidity: 9.07 g/m<sup>3</sup> | Water Activity: 0.674 (aw)

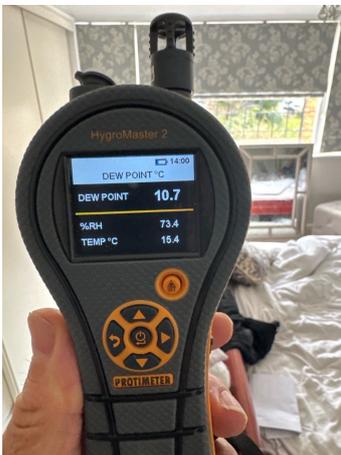
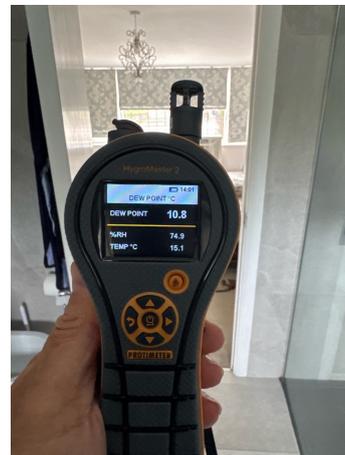
## MASTER BEDROOM + ENSUITE

Vapour Pressure: 1.28 kPa | Relative Humidity: 73.4% | Temperature: 15.4°C | Dew Point: 10.7°C | Absolute Humidity: 9.61 g/m<sup>3</sup> | Water Activity: 0.732 (aw)

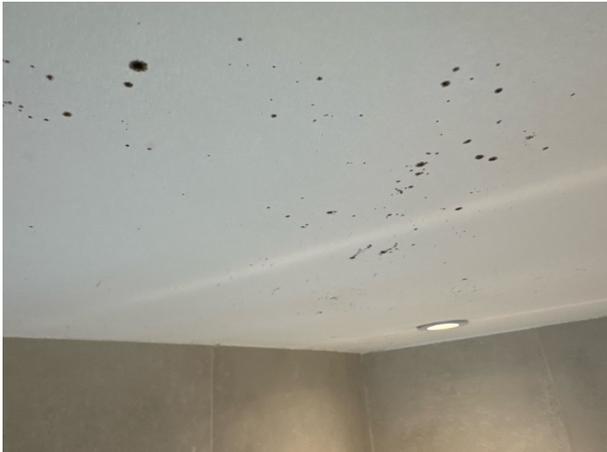
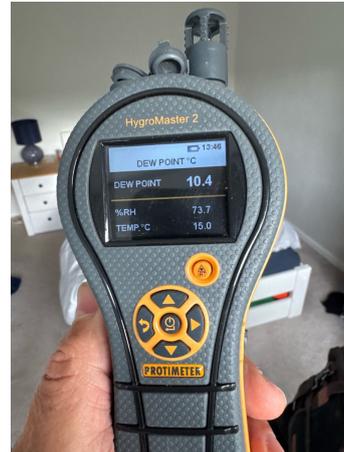
## BATHROOM

Localised mould growth was observed within the family bathroom, primarily affecting upper wall and ceiling areas. This room does not benefit from dedicated mechanical extraction. The pattern and distribution of mould are consistent with condensation-related moisture accumulation due to elevated humidity and inadequate ventilation, rather than structural water ingress.

Vapour Pressure: 1.26 kPa | Relative Humidity: 73.7% | Temperature: 15.0°C | Dew Point: 10.3°C | Absolute Humidity: 10.50 g/m<sup>3</sup> | Water Activity: 0.739 (aw)
