# DAMP & TIMBER SURVEY

**PROPERTY:****Bishop's Stortford CM23, UK**

REF NO: 15112200

**SURVEY PREPARED BY:****Ed Harrison (FODCS Certificated Damp Surveyor)**

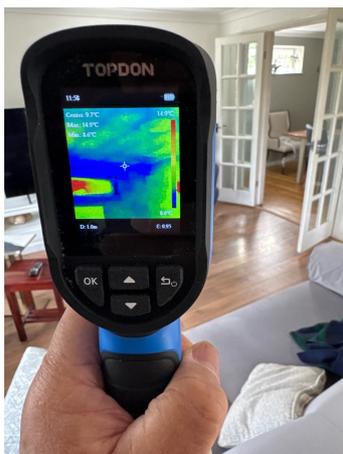
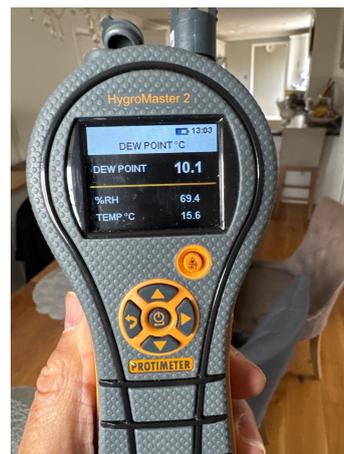
### EXTENTION

Vapour Pressure: 1.17 kPa | Relative Humidity: 50% | Temperature: 20.0°C | Dew Point: 9.3°C | Absolute Humidity: 8.65 g/m<sup>3</sup> | Water Activity: 0.501 (aw)

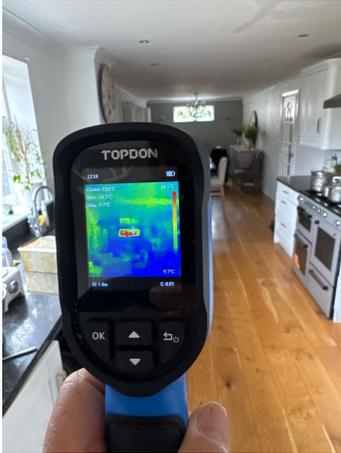
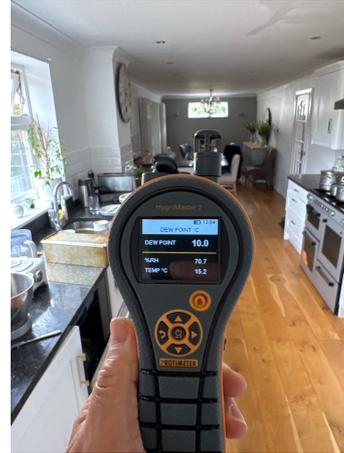
## KITCHEN

Vapour Pressure: 1.17 kPa | Relative Humidity: 50% | Temperature: 20.0°C | Dew Point: 9.3°C | Absolute Humidity: 8.65 g/m<sup>3</sup> | Water Activity: 0.501 (aw)

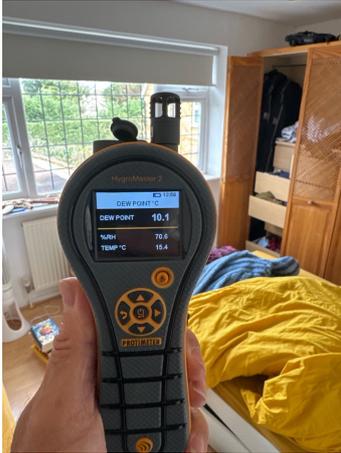
## BEDROOM 2

Vapour Pressure: 1.32 kPa | Relative Humidity: 70.6% | Temperature: 16.4°C | Dew Point: 10.1°C | Absolute Humidity: 9.88 g/m<sup>3</sup> | Water Activity: 0.708 (aw)

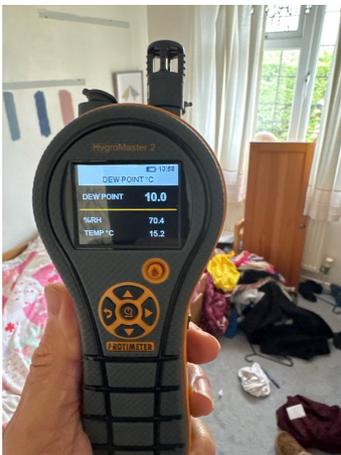
## BEDROOM 3

Vapour Pressure: 1.22 kPa | Relative Humidity: 70.4% | Temperature: 15.2°C | Dew Point: 9.8°C | Absolute Humidity: 10.00 g/m<sup>3</sup> | Water Activity: 0.707 (aw)
